## Berlin-Steglitz storm sewer

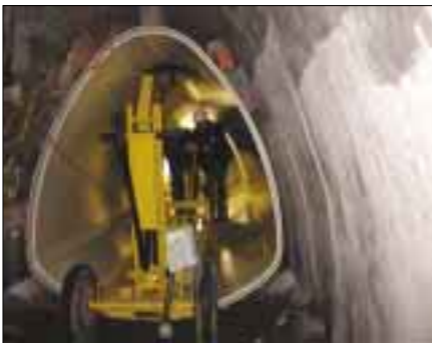
*HOBAS NC Line pipe installation*

The HOBAS pipes were joined with push-on couplings bonded in place by laminate hand lay-up. Precautions were also taken during installation to prevent flotation. After tightness testing to DIN EN 1610 procedure „W“, grout was injected section by section.
