## Rehabilitation of an egg-shaped interceptor in Hildesheim

## Berlin-Steglitz storm sewer

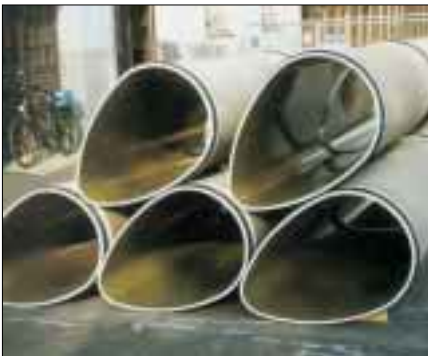
*The DN 680/1050 relining pipes stored in front of the access shaft.*

structural dimensioning of the liner. Egg-shaped DN 680/1050 pipes with a wall thickness of 10 mm were selected for rehabilitation. They were inserted separately into the old sewer through a short shaft at the end of the relining section. After being joined, each pipe was prevented from floating at the crown of the old sewer.

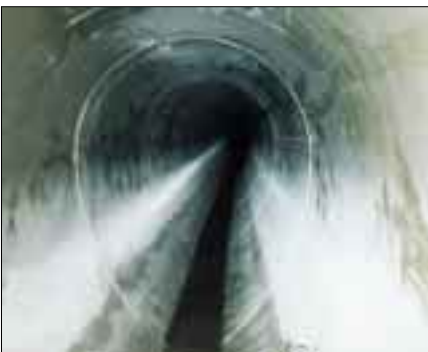
*View into the rehabilitated sewer.*

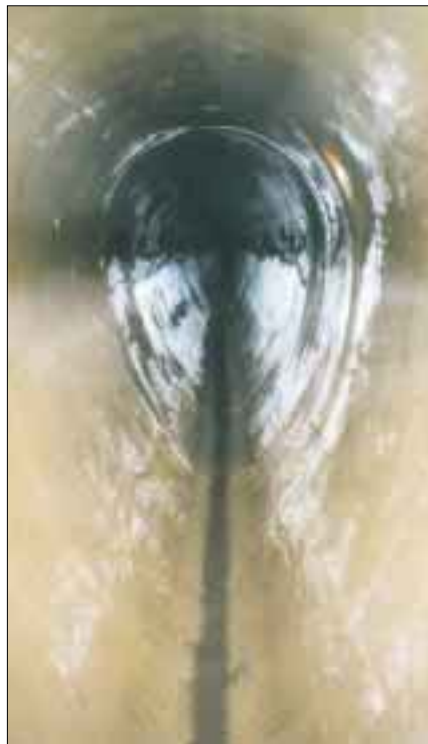
*Rehabilitated sewer with DN 200 laminated inlet*

The lengths of 2.0 m and 3.0 m combined with the simple jointing system enabled the liner pipes to be laid rapidly. As a result, installation was completed within six days. The storm sewers from the various properties were connected to the interceptor with laminate hand lay-up. To check leak tightness, the liner was then filled with water. Finally, the remaining annulus between the liner pipe and old sewer was completely filled with special cement (grout).

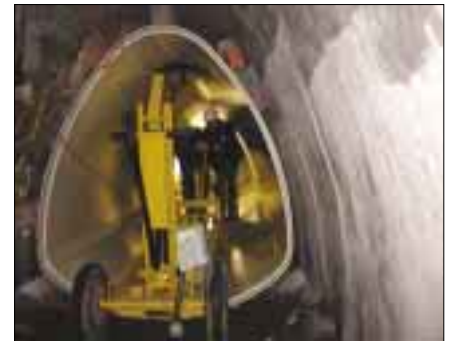
*HOBAS NC Line pipe installation*

The HOBAS pipes were joined with push-on couplings bonded in place by laminate hand lay-up. Precautions were also taken during installation to prevent flotation. After tightness testing to DIN EN 1610 procedure „W“, grout was injected section by section.
